INDG395 03/04 C1000
Printed and published by the Health and Safety Executive

Avoiding falls from vehicles

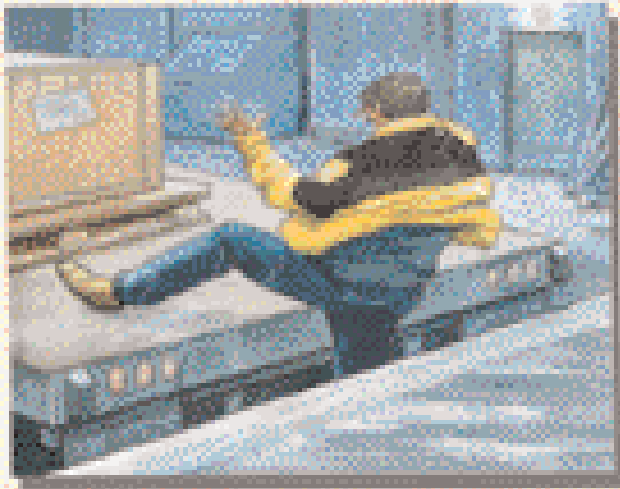
■ CASE STUDY 2

A worker was crossing a gap between a loading bay and vehicle to empty a trailer on a dark, damp night. He fell 1 m, breaking a leg.

The accident occurred because the employer failed to identify a 1 m drop as a possible cause of serious injury. This was despite the fact that other trailers, where the drop was only slightly more, were provided with a bridging device to eliminate the gap and prevent falls.

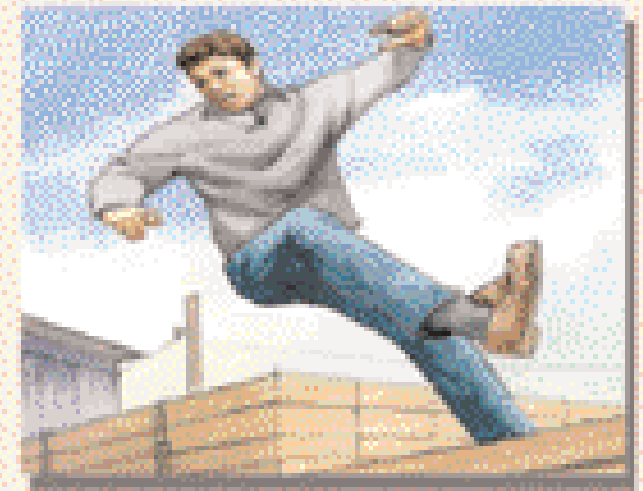
CASE STUDY 1

A joiner suffered severe head injuries when he fell approximately 2 m from the top of a stack of timber on the back of a flat-bed lorry.

The joiner was helping to unload a delivery of timber when he climbed on top of the stack. While edging along the stack, he lost his footing and fell. A raised bay with a concrete platform was available to provide safe access for unloading vehicles, but was not used.

The joiner should have received instruction on how to unload safely, eg by using the unloading bay. Better supervision would have ensured that he complied with those instructions. Climbing on top of loads should be avoided wherever possible.
